**UNITED STATES ENVIRONMENTAL PROTECTION AGENCY
REGION 7**

RE: CertainTeed Corporation – Pipe and Foundations Group
McPherson, Kansas
RCRA ID No.: KSD020774337

Request for Information

CertainTeed Corporation – Pipe and Foundations Group
McPherson, Kansas
RCRA ID No.: KSD020774337

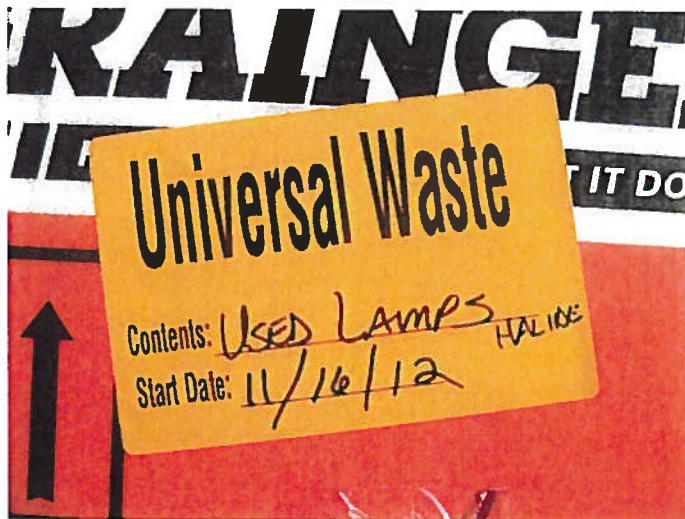
CertainTeed Response to Citation 4 d

- d. Colletti Freeway – Full open, unlabeled, and undated box of spent metal halide lamps (see waste stream #13 and photo 5).
5. **No Annual Training (NOV #A.5)** – According to KAR 28-31-262a(d)(1)(B), **employees are to be trained annually and records are to be kept of each employee trained, date of training and topics covered.** Mr. Miller provided training documents that included a 2012 Master Roster, 2011 Hazardous Waste /Universal Waste General Training, 2011 and 2012 Flammable & Combustible Liquids Training (see attachments 12A through 12D). I randomly selected four employees that handle hazardous waste to determine what training they had received since the previous 2/21-23/2011 inspection. They included Mr. Zimmer and Joe Demaio who had no documented training for the 2011 Hazardous Waste /Universal Waste General and 2011 Flammable & Combustible Liquids Training (see attachments 12B and 12C).

The metal halide bulbs were placed into an approved container, labeled as Universal Waste and dated on November 16, 2012.

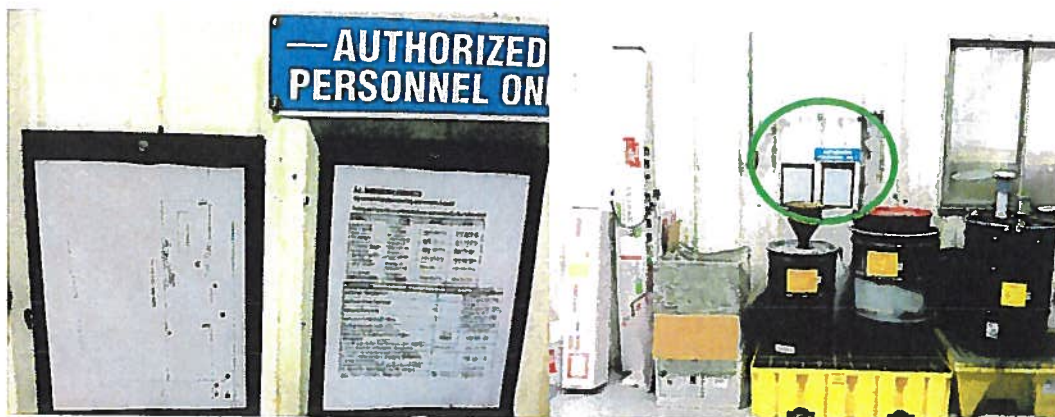
Description of violation - No posted emergency info in storage area – Citation 40CFR262.34 (d) (5) (ii)

Please see the photo's below documenting the placement of emergency information: appropriate contact phone numbers of plant emergency coordinators, local emergency responders, and a facility map identifying locations of response equipment such as fire extinguishers and a spill kit. This information was posted in the accumulation area prior to the completion of the Inspection. Copies of documents will be provided in packet of information (Attachment #1)
